# Hard Metal Exposures. Part 1: Observed Performance of Three Local Exhaust Ventilation Systems

Not every ventilation system performs as intended; much can be learned when they do not. The purpose of this study was to compare observed initial performance to expected levels for three saw-reconditioning shop ventilation systems and to characterize the changes in performance of the systems over a one-year period. These three local exhaust ventilation systems were intended to control worker exposures to cobalt, cadmium, and chromium during wet grinding, dry grinding, and welding/brazing activities. Prior to installation the authors provided some design guidance based on *Industrial Ventilation, a Manual of Recommended Practice*.<sup>(7)</sup> However, the authors had limited influence on the actual installation and operation and no line authority for the systems. In apparent efforts to cut costs and to respond to other perceived needs, the installed systems deviated from the specifications used in pressure calculations in many important aspects, including adding branch ducts, use of flexible ducts, the choice of fans, and the construction of some hoods. After installation of the three

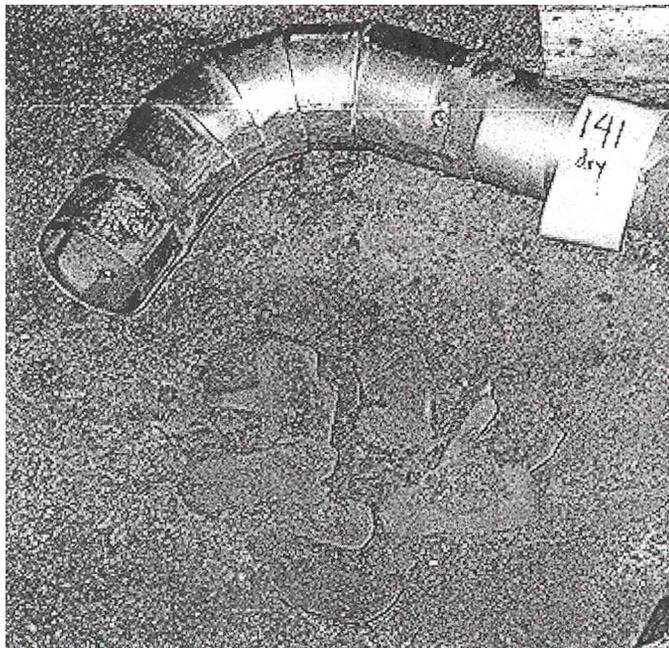
**FIGURE 5**

The buildup of sticky material was a widespread problem. In general, the worst cases in each of the three systems were associated with grinding, which tended to fill ducts quickly with compacted clumps of grinding materials (see Figure 5). The grinding wheels contained a binder that when abraded released a sticky resin that bound the metal dust into increasingly large hardened clumps. These clumps easily blocked the duct work, almost always within 10 diameters of duct length near elbows and at the hood entrances. No settling was observed beyond the most upstream vertical duct in branches or in submains or mains. The investigators themselves sometimes cleaned out the branch ducts; otherwise, the incidence of plugging in ducts may have been greater. Because the investigator cleaning was done after measurements were taken on a given day, the beneficial effects of that cleaning were lost in the re-accumulation of materials during the following month. At six months it was clear that cleaning

Settled material partially plugging duct number 12 in Roundsaw Dry.

should be done on a weekly basis. The authors counseled the management and demonstrated cleaning to the employees. In succeeding months substantial accumulations still were evident by even casual external inspection.

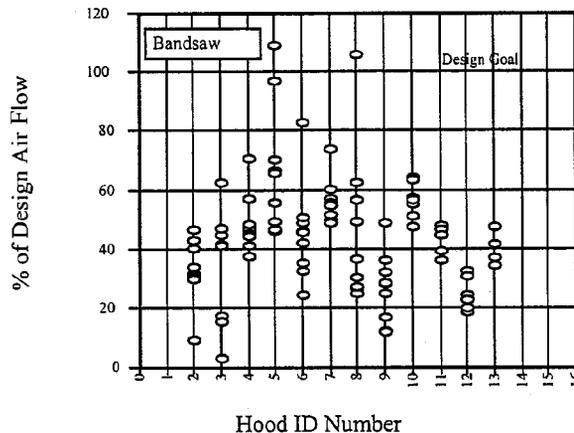
**FIGURE 6**

Air flow statistics for Bandsaw ventilation system by hood.

The actual air flows through individual hoods were between 20 and 109 percent of design values (Figure 6). The highest air flows for a given hood corresponded to cases where its duct was not plugged but other ducts were. The band saw hoods almost never reached design air flows, in part because the overall air flow levels at the fan were very low. As shown in Figure 4, the total air flow to the system dropped from a high of about 60 percent

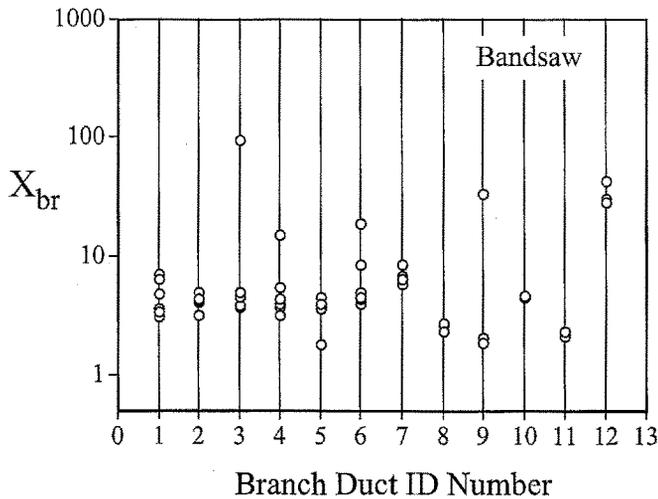
**FIGURE 7**

Bandsaw branch resistances ( $X_{br}$ ) to flow over time.

As shown in Figure 7, the resistance to flow for most branch ducts ( $X_{br}$ ) varied greatly for several of the ducts. The branch ducts that ventilated grinding (ducts 1 to 7) were nearly always coated or partially plugged. The extreme values of  $X_{br}$  for a given branch indicate times of substantial blockage. The other values were associated with the varying degrees of moderate coating and blockage, which were difficult to rank order by degree due to the lengthy times between viewings and often poor visual access. Ducts 3, 4, 6, and 9 showed large excursions in resistances, indicative of severe plugging. The changes in values for duct 1 may have been due to varying degrees of kinking for the 15-foot-long flexible duct connected to it, in addition to the effects of varying degrees of plugging. Ducts 8 to 11 were never coated or clogged. Changes to their  $X_{br}$  values were attributable in each case to modifications to the ducts or hood that affected resistance to flow. Duct 12 had a highly obstructed hood entry for every round of measurements.

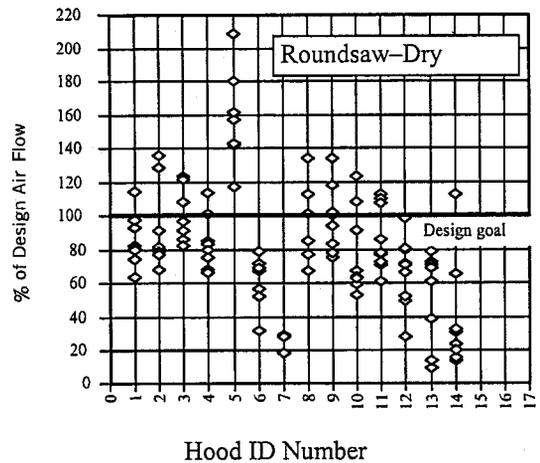
**FIGURE 8**

Air flow statistics of Roundsaw-Dry ventilation system by hood.

The air flows through hood 5 were consistently much higher than intended, but all other hoods' air flows were below design levels for at least half of the months sampled (see Figure 8). The hood air flows were highly variable, but less than 10 percent of the variance was explained by the declining total air flows (see Table II). The coefficient of variation was 24 percent for changes in hood air flows due to shifts in relative distribution as some branch ducts were partially plugged or cleaned to differing degrees than others.

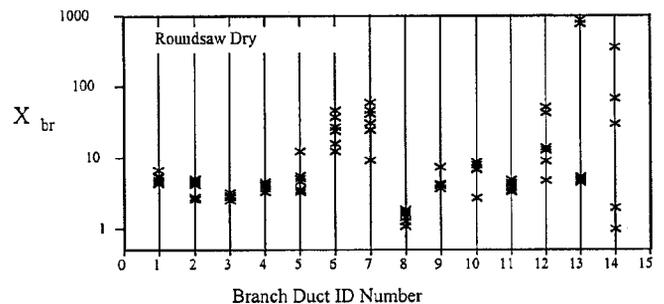
**FIGURE 9a**

Roundsaw Dry branch resistances for each branch duct.

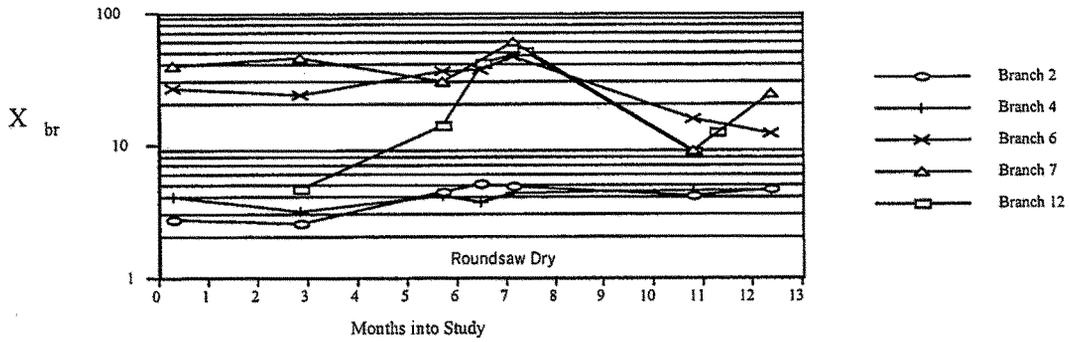
Hoods 6, 7, and 12 were grinders with integral hoods having very narrow duct inlets that easily clogged and were difficult to access for cleaning. Their chronic heavy plugging (see Figure 5) produced the high  $X_{br}$  values shown in Figures 9a and 9b. As shown in Figure 9c, all three appeared to benefit from a thorough cleaning just after the tenth month. The brazing hoods (ducts 10 and 13) were lightly coated with brazing residues but had little buildup. The bimodal distribution of  $X_{br}$  values for duct 10 (see Figure 9a) was due to a change in hood design. The initial high values for duct 13 (see Figure 9c) dropped to a much lower, nearly constant value when a rag inside the duct was discovered and removed.

**FIGURE 9b**  
 $X_{br}$  for branches 2, 4, 6, 7, and 12.

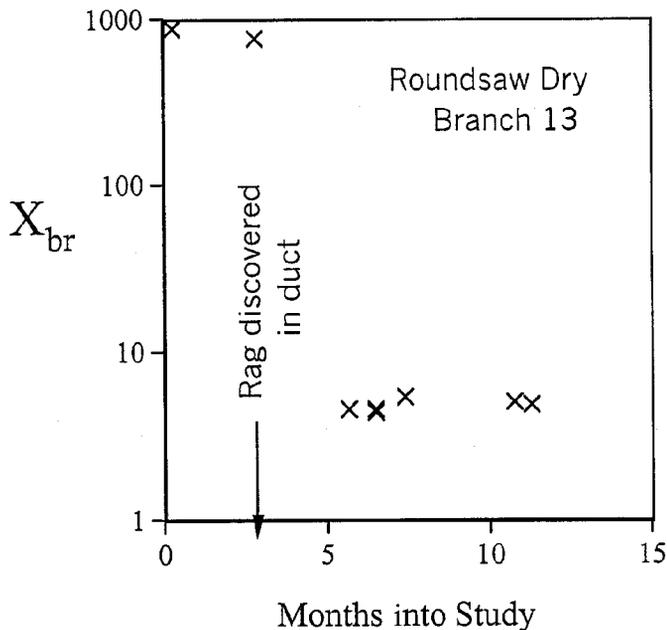
**FIGURE 9c**  
 $X_{br}$  for branch 13.

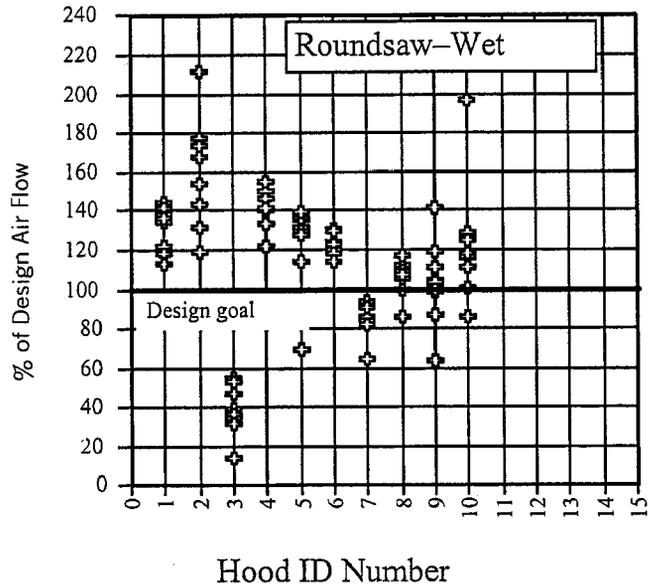
The Roundsaw-Wet ventilation system exceeded design air flows more often than the other two systems (Figure 4). Only hoods 3 and 7 were consistently below design goals throughout the study period (see Figure 10). However, the hood air

**FIGURE 10**  
 Air flow statistics of Roundsaw-Wet ventilation system by hood.

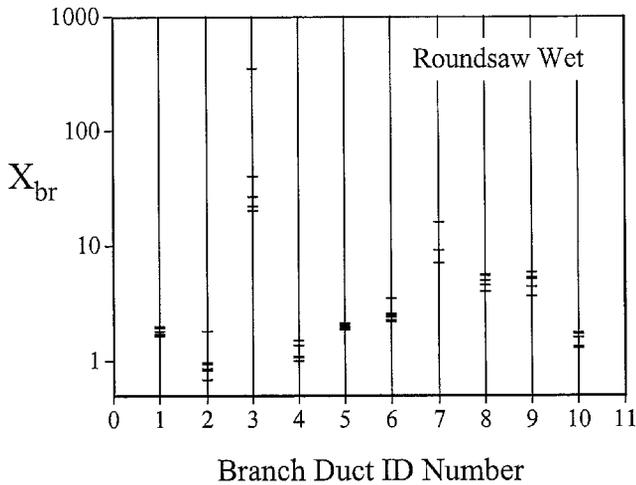
**FIGURE 11**

Although some ducts experienced sharp changes in resistance to flows (see Figure 11), the changes to resistance were much more modest for this system than for the other two, indicating

Roundsaw Wet branch resistances to flow over time.
