# Hard Metal Exposures. Part 1: Observed Performance of Three Local Exhaust Ventilation Systems

Not every ventilation system performs as intended; much can be learned when they do not. The purpose of this study was to compare observed initial performance to expected levels for three saw-reconditioning shop ventilation systems and to characterize the changes in performance of the systems over a one-year period. These three local exhaust ventilation systems were intended to control worker exposures to cobalt, cadmium, and chromium during wet grinding, dry grinding, and welding/brazing activities. Prior to installation the authors provided some design guidance based on *Industrial Ventilation, a Manual of Recommended Practice*.<sup>(7)</sup> However, the authors had limited influence on the actual installation and operation and no line authority for the systems. In apparent efforts to cut costs and to respond to other perceived needs, the installed systems deviated from the specifications used in pressure calculations in many important aspects, including adding branch ducts, use of flexible ducts, the choice of fans, and the construction of some hoods. After installation of the three

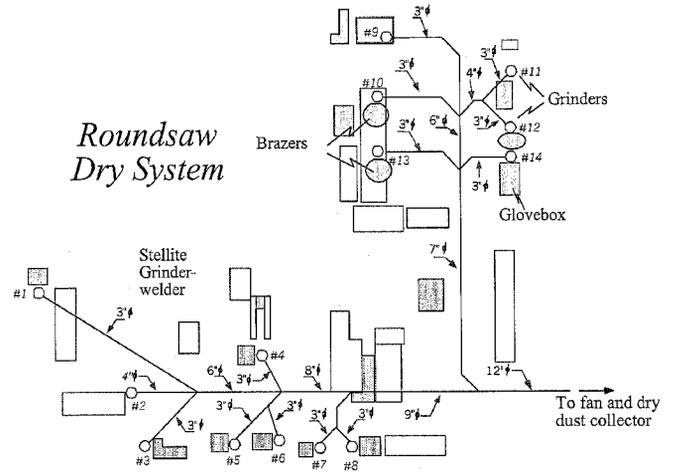
**FIGURE 2**  
Layout of the Roundsaw-Dry system.

8. For Roundsaw-Dry ventilation system (see Figure 2), the estimated total required exhaust flow rate of

3200 cfm with a total static pressure of 7.75 inches water gauge at the collector inlet. A Torit Model 30FB Cyclone with an after-filter section and fan was installed to provide the air flows and pressures. The design transport velocity was 4200 fpm. The system required a dry dust unit similar to the existing collector with an after-filter for dry grinding.

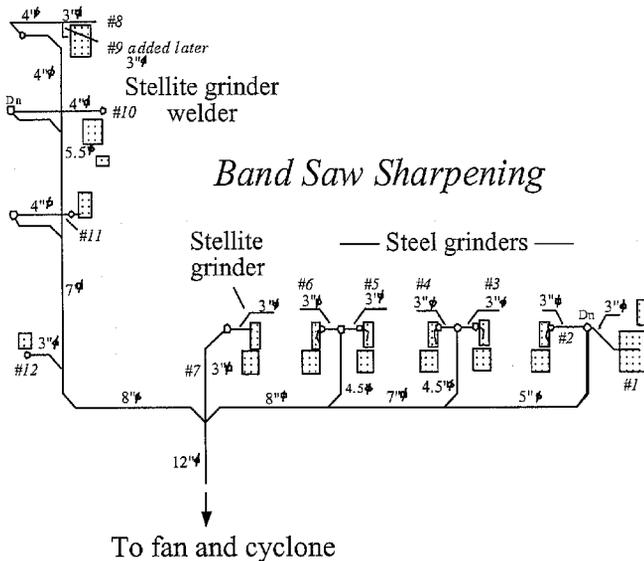
**FIGURE 1**  
Layout of the Bandsaw system.

7. For the Bandsaw ventilation system (see Figure 1), design air flow rates ( $Q_T$ ) at the grinders were based on criteria from *Industrial Ventilation*,<sup>(7)</sup> the physical size of the incorporated exhaust hood of the grinding machine, and the size and speed of the grinding wheels.<sup>(7)</sup> The design transport velocity was 4000 fpm. The estimated total required air flow was 3000 cfm and the fan pressure was 7.5 inches water gauge. The system included a dry dust collection system that utilized the existing fan/collector unit. A bag type after-filter was added to the unit to capture the fine dust particles that pass through the cyclone collector.

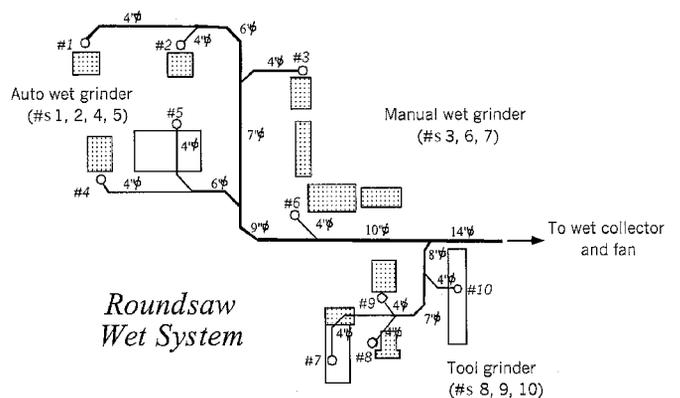
**FIGURE 3**  
Layout of the Roundsaw-Wet system.

9. The Roundsaw-Wet ventilation system (see Figure 3) design transport velocity was 3500 fpm. The estimated total required exhaust flow rate was 3500 cfm with a static pressure of 6.0 inches water gauge at the collector inlet. The wet collector for the system was a Torit Dryflo Model D2 Mist Collector. Because wet grinding operations generally produce a fine airborne mist, enclosures around the grinders were recommended (and actually installed).

Only one of the wet grinders had a factory-built exhaust hood incorporated in the grinding machine. Branches 7 to 9 included roughly 10 feet of flexible duct. The wet grinding machines required enclosures to contain the fine spray of coolant generated by grinding. The design engineer recommended enclosing the back, sides, top, and as much of the front as possible for all wet grinding machines. He also recommended using a light-weight clear plastic strip curtain at machine openings where access was required. Those recommendations were not implemented. Instead, a plain duct opening was placed near the source to act as a simple, unflanged capturing hood.
